# Safety Inspection Report

Annual Inspection

## Claydon's Field

Tiffield Parish Council

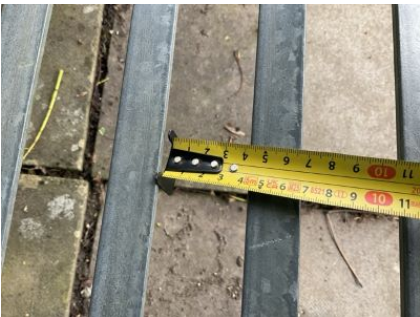
The gaps between the slats exceed 30 mm and are known to cause entrapments.

No reasonably practicable action is identified.

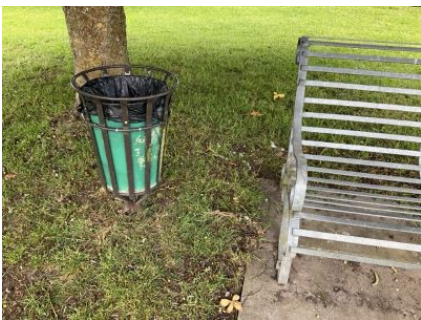
RoSPA recommends that litter bins should not be closer than 2 m from seats and gates (max of 3 m recommended). If they are too far away they may not be used. If they are too close this may cause nuisance from wasps.

Move the bin or seat as appropriate.

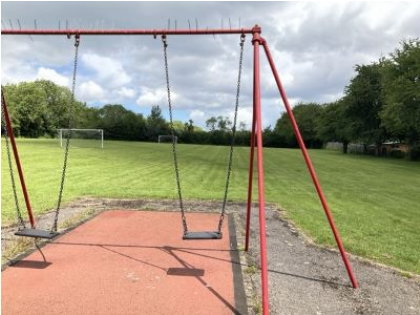
The distance between the seat side and the support is insufficient.

No reasonably practicable action is identified.

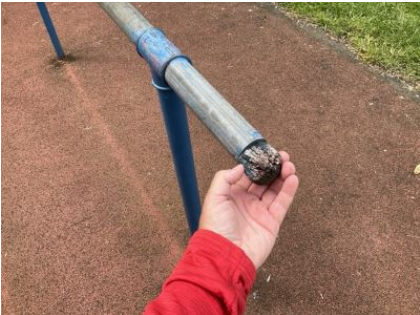
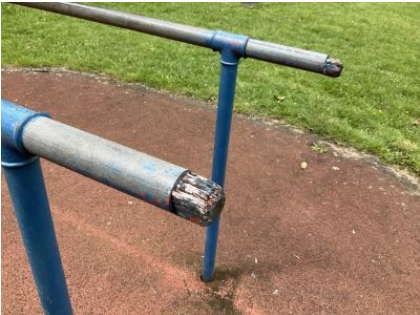
Rough surfaces which present a risk of injury.

Smooth off the timber plugs.

Smooth off.

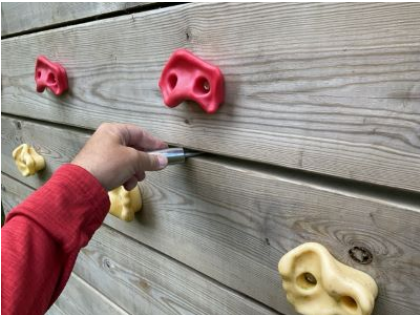
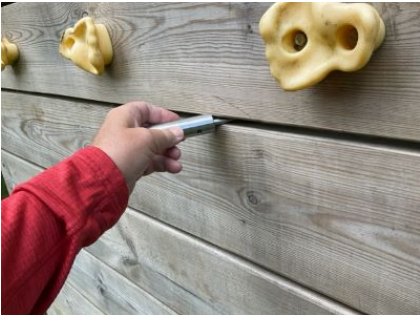
Finger entrapment.

Between the slats.

Eliminate the entrapment.

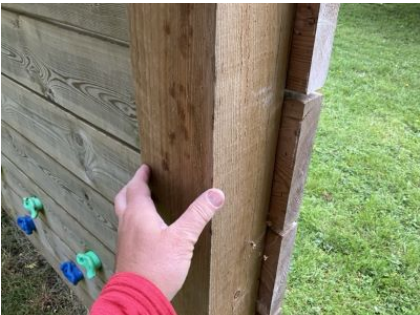
Edges not radiused or chamfered.

Posts not radiused.

Provide a minimum 3 mm radius.

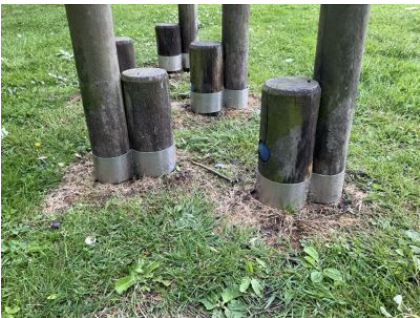
Additional comments are noted below.

Ground post covers prevent access and inspection of the timbers at ground level. The covers will hold moisture and could possibly reduce the life span of the timber and negate manufacturer’s warranty. Consider removal.

Read the notes for further action.

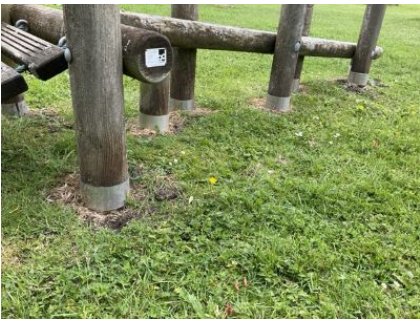
Strimmer damage is present on posts, allowing water to enter and timbers to soften. It can also remove the protective envelope around the timber. Prevent further damage and check timbers for decay throughout the year.

Ground post covers prevent access and inspection of the timbers at ground level. The covers will hold moisture and could possibly reduce the life span of the timber and negate manufacturer’s warranty. Consider removal.

Prevent further damage., Read the notes for further action.

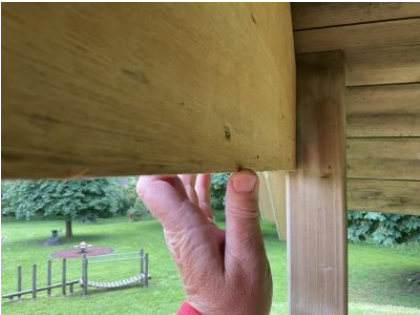
Edges not radiused or chamfered.

Edges on the ply board.

Provide a 3 mm radius or 3 mm chamfer.

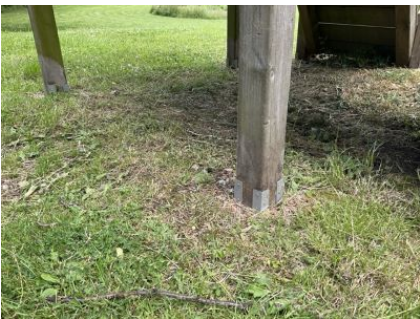
Strimmer damage is present on posts, allowing water to enter and timbers to soften. It can also remove the protective envelope around the timber. Prevent further damage and check timbers for decay throughout the year.

Prevent further damage.

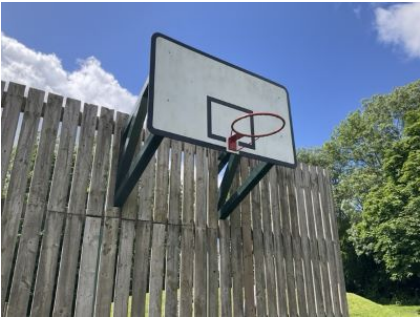
A clearly visible sign must be fitted to all sports related equipment with at least the following: a) equipment is not intended for children less than 36 month, b) "Do not climb on the framework or nets", c) "Do not hang on the ring", d) "Do not wear rings or other jewellery as these can get caught and cause injury", e) name and telephone number of site owner, f) number to call in case of accident.

Fit warning notice.

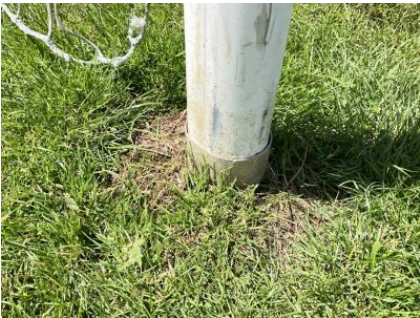
Hard or sharp projections.

Ground socket raised above the ground and is damaged leaving sharp edges.

Remove hard, pointed and sharp projections.

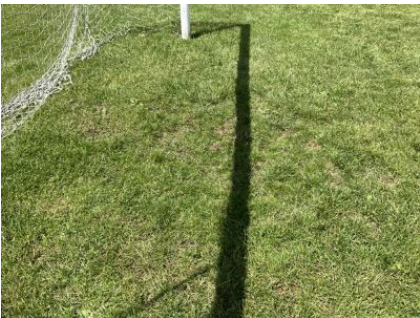
| Description | Tasks | Risk score |
|---|---|---|
| Ground erosion present. | No reasonably practicable action identified. | 6 |

Goal mouth near play area is wearing. Either soil and seed affected area or re-turf affected area.

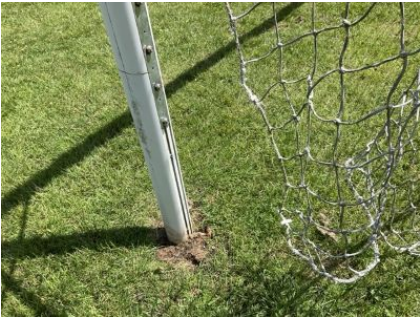
| Description | Tasks | Risk score |
|---|---|---|
| Item is not secure. | Secure. | 4 |

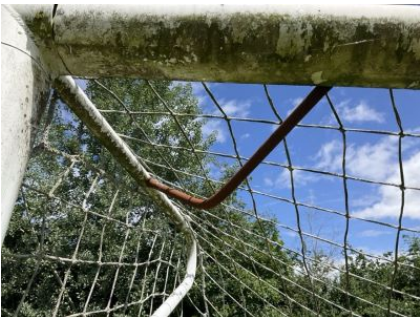
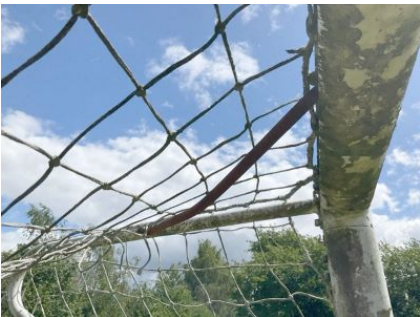
| Description | Tasks | Risk score |
|---|---|---|
| Item is bent. | Repair. | 3 |

Repair.
